SUSQUEHANNA RIVER BASIN
KETTLE CREEK, BLAIR COUNTY

BRUSH MOUNTAIN DAM

NDI I.D. NO: 539

PHASE I INSPECTION REPORT
NATIONAL DAM INSPECTION PROGRAM

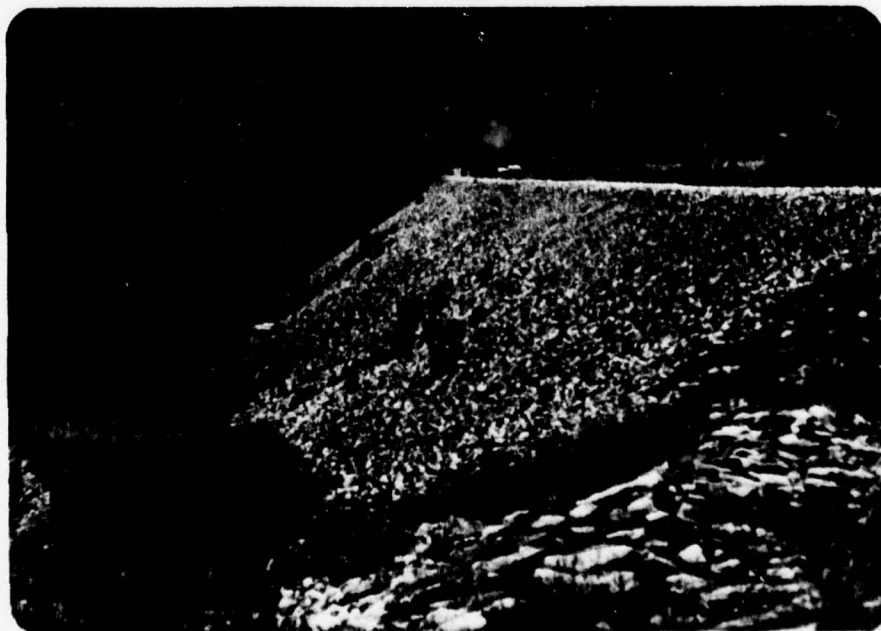
Downstream Face

3. Surficial slides in the downstream riprap were observed. These slides appeared to be causing bulges in the riprap near the toe of the dam.

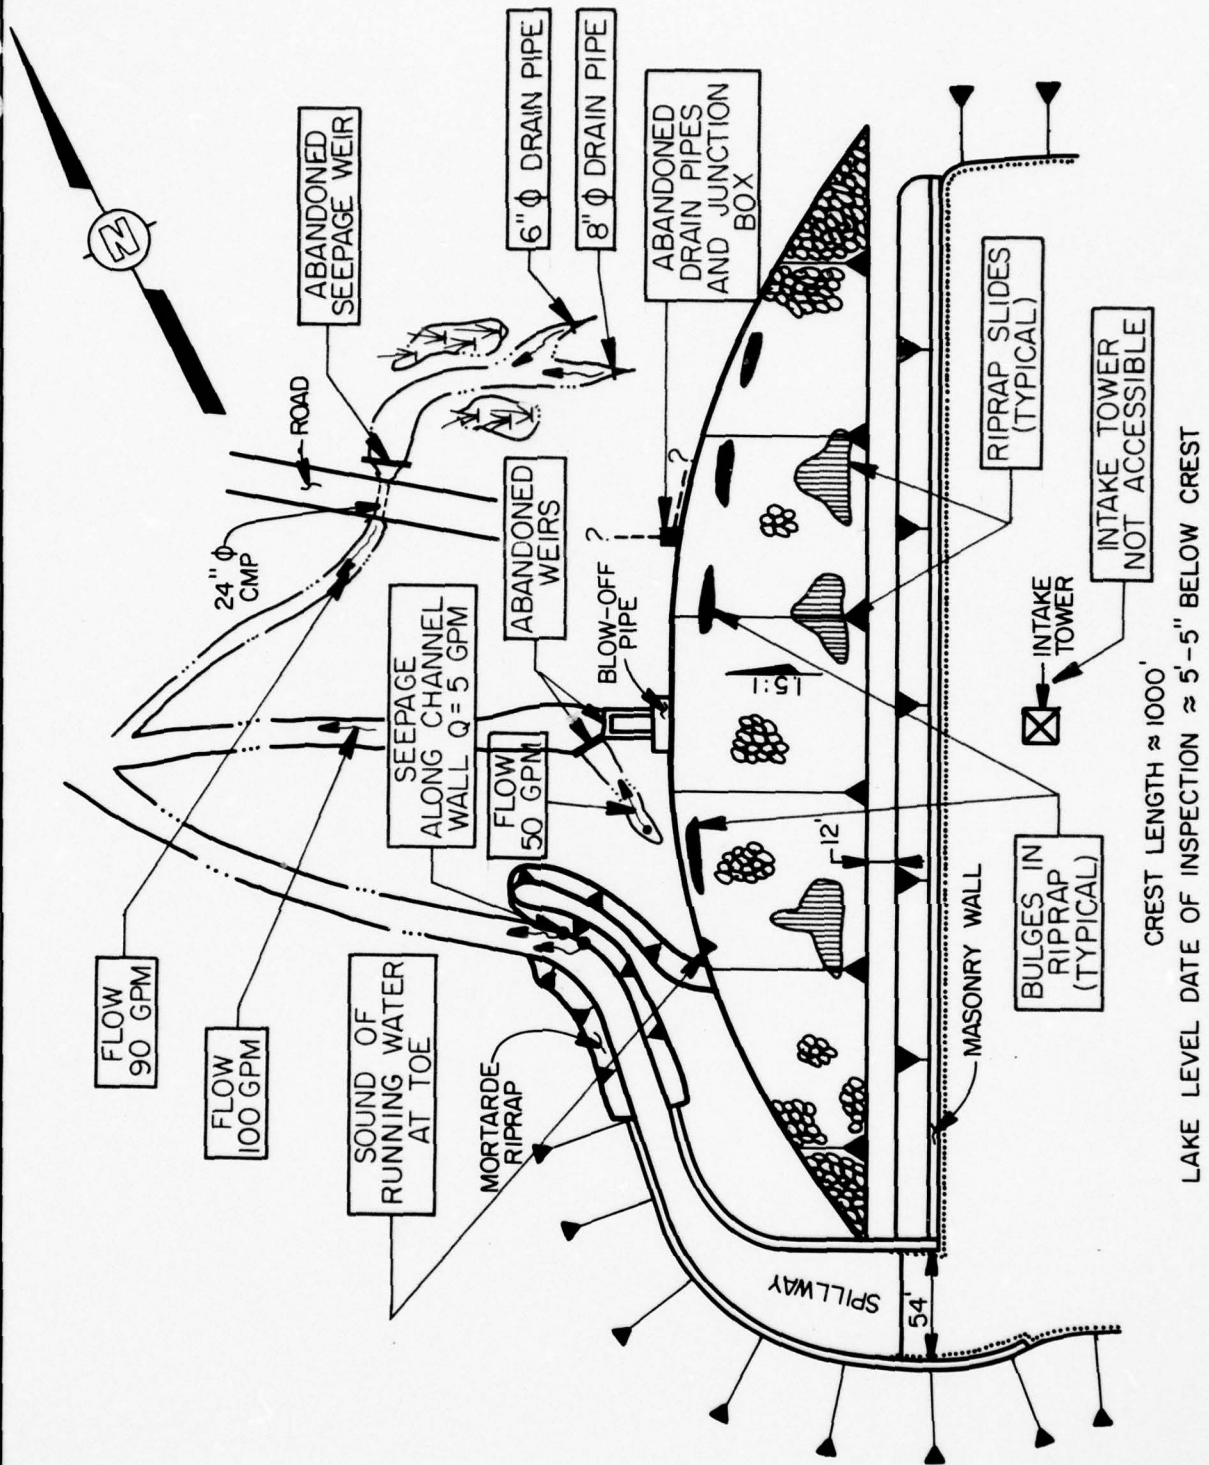
PLATE 6

1. All seepage areas observed at the toe of the dam (Plate 6) coincided with the seepage areas that previously existed as implied by the locations of the monitoring weirs (Plate 5). Total seepage flow from the right abutment area was estimated to be 90 gallons per minute (gpm). The seepage on the left side of the outlet works discharge channel was estimated to be 50 gpm. Total flow in the outlet works discharge channel was estimated to be 100 gpm.
2. Minor seepage was observed in the spillway discharge channel and the seepage quantity was estimated to be 5 gpm.

BRUSH MOUNTAIN DAM
 GENERAL PLAN
 FIELD INSPECTION NOTES
 FIELD INSPECTION DATE : JULY 10 , 1978

VISUAL EXAMINATION OF	OBSERVATIONS	REMARKS OR RECOMMENDATIONS
MONUMENTATION/SURVEYS	NONE FOUND	
OBSERVATION WELLS	NONE FOUND.	
WEIRS	THREE SEEPAGE WEIRS AT LOCATIONS SHOWN IN PLATE. 6 WEIRS ARE <u>NOT</u> FUNCTIONAL.	
PIEZOMETERS	NONE FOUND.	
OTHER	NONE.

4. It is recommended that the owner repair the seepage weirs at the toe of the dam and monitor and record seepage quantities regularly.
5. It is recommended that the owner repair the riprap slides on the downstream slope of the dam to avoid future erosion problems.
6. Because the dam may overtop during unusually high runoff, it is recommended that during such periods the owner should provide around-the-clock surveillance for early detection of problems, such as erosion. It is also recommended that the owner should develop a formal warning system to alert the downstream residents in the event of emergencies.
7. It is recommended that the owner be advised that the dam and appurtenant structures should be inspected regularly and properly maintained.

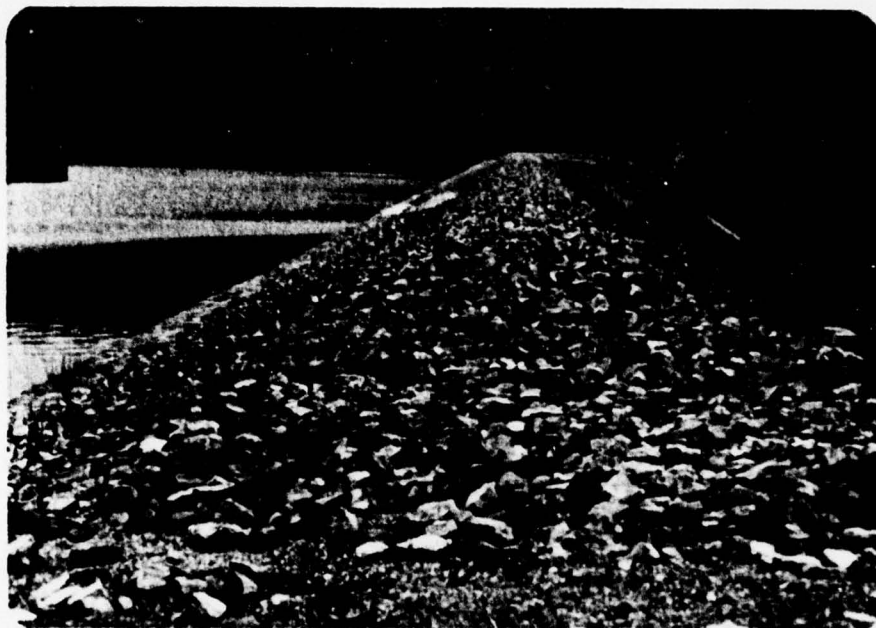
Photograph No. 1
Crest (looking south).

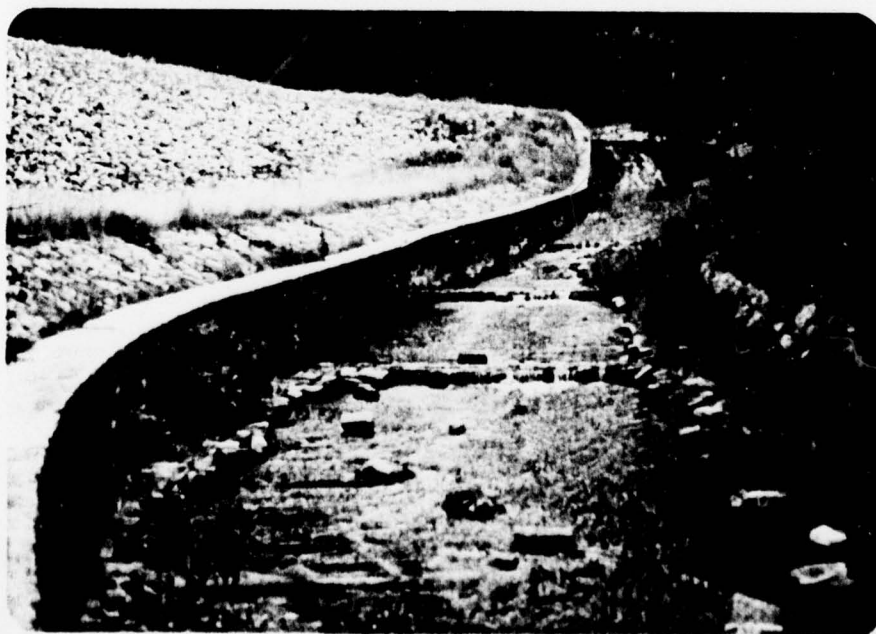
The spillway structures were examined for deterioration or other signs of distress and obstructions that would limit flow. It was observed that most of the grouted riprap channel floor pavement that was constructed in 1936 in the spillway channel below Elevation 1693 has been eroded away; however, this has not affected the overall performance of the channel. The remaining parts of the spillway are considered to be in good condition.

VISUAL EXAMINATION OF	OBSERVATIONS	REMARKS OR RECOMMENDATIONS
CONCRETE WEIR	BROAD CRESTED WEIR - GOOD CONDITION	
APPROACH CHANNEL	SHALLOW - NO SIGNIFICANT OBSTRUCTIONS TO FLOW.	
DISCHARGE CHANNEL	RECTANGULAR CHANNEL. MASONRY LINING IN THE LOWER HALF IS ERODED.	
BRIDGE AND PIERS	NONE.

Photograph No. 2
Spillway discharge channel.

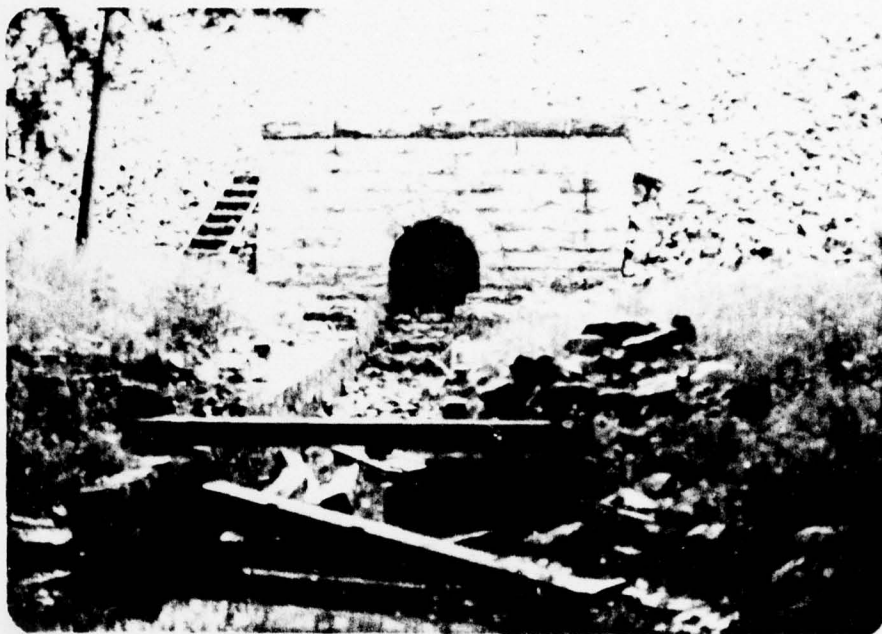
Photograph No. 3

The downstream end of the outlet pipe was examined and was found to be in fair condition.

Outlet works.

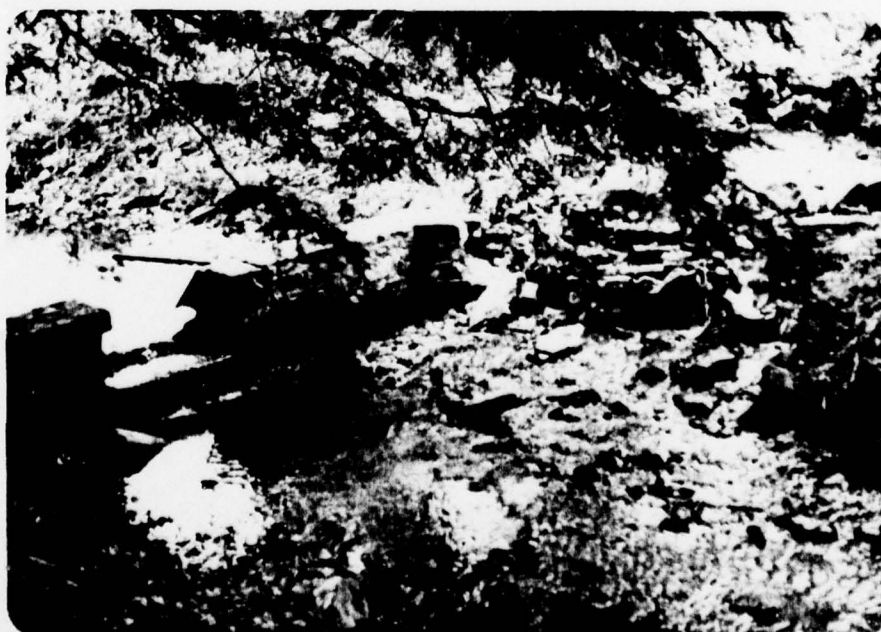
Photograph No. 4

Seepage from outlet works and left abutment.

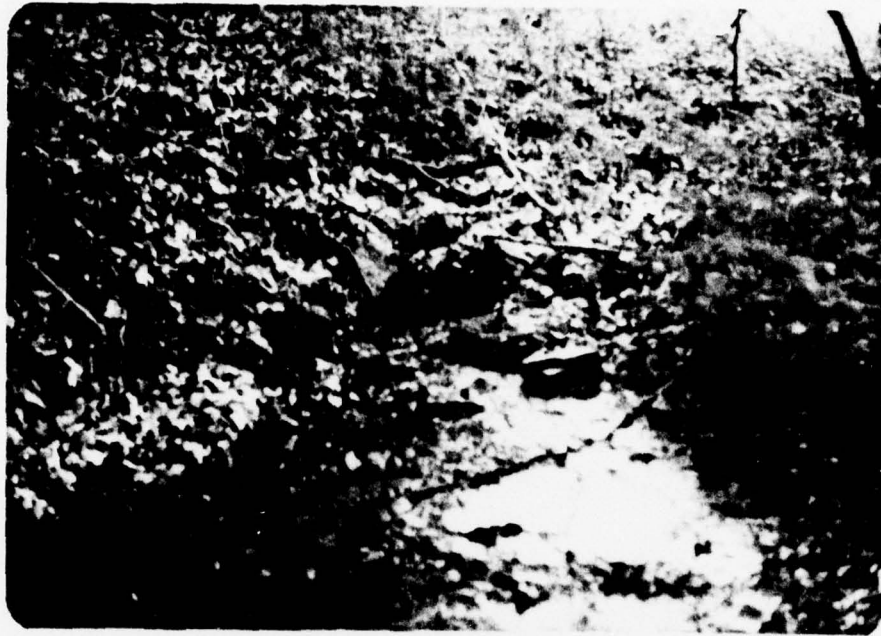
Photograph No. 5
Seepage from right abutment.
